MISCELLANEOUS PAPER SL-83-17

EVALUATION OF CONCRETE CORES CARUTHERSVILLE FLOODWALL

G. Sam Wong

September 1983
Final Report

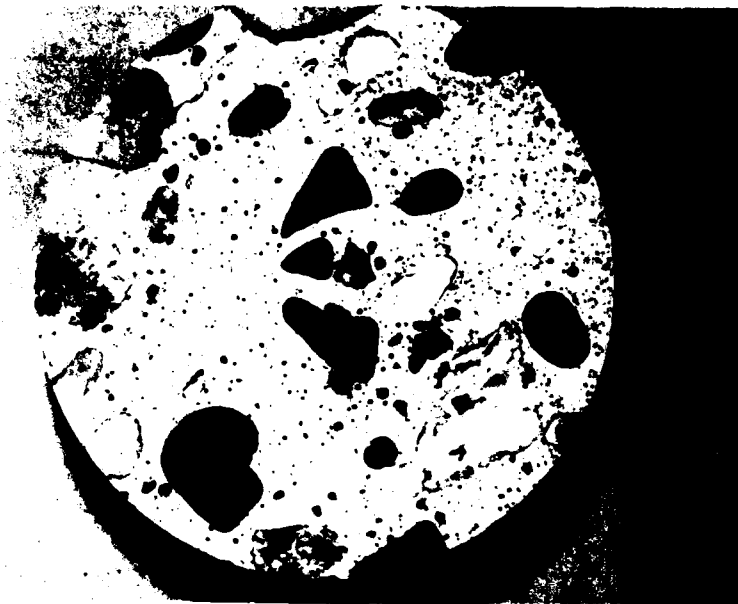
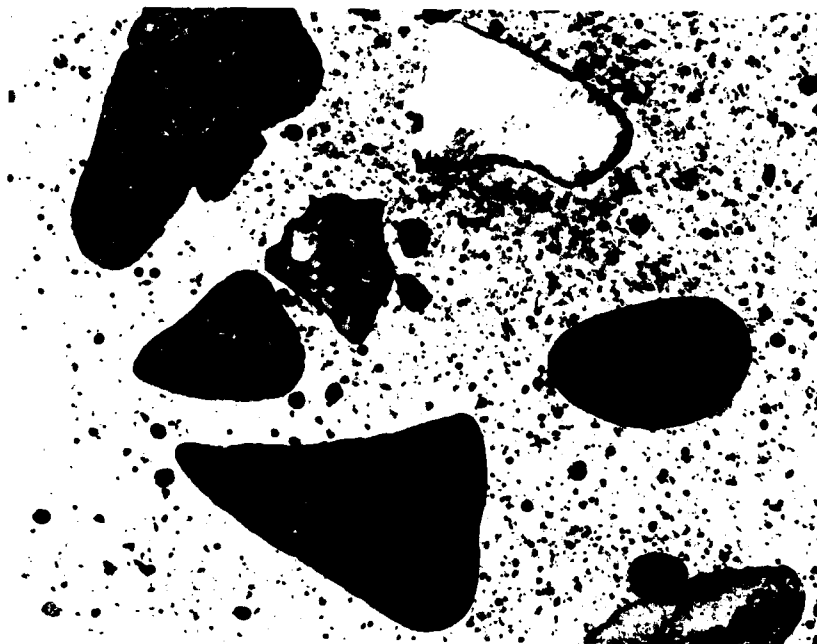
Photograph 1. Core MEM-5 CON-1 is concrete typical of the 1932 construction. No entrained air voids, oversanded and both gravel and sand appear gap graded

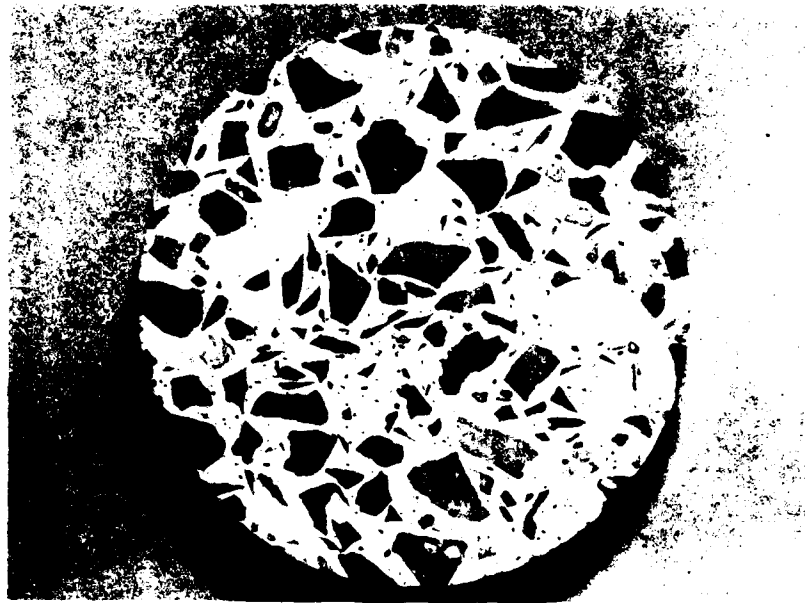
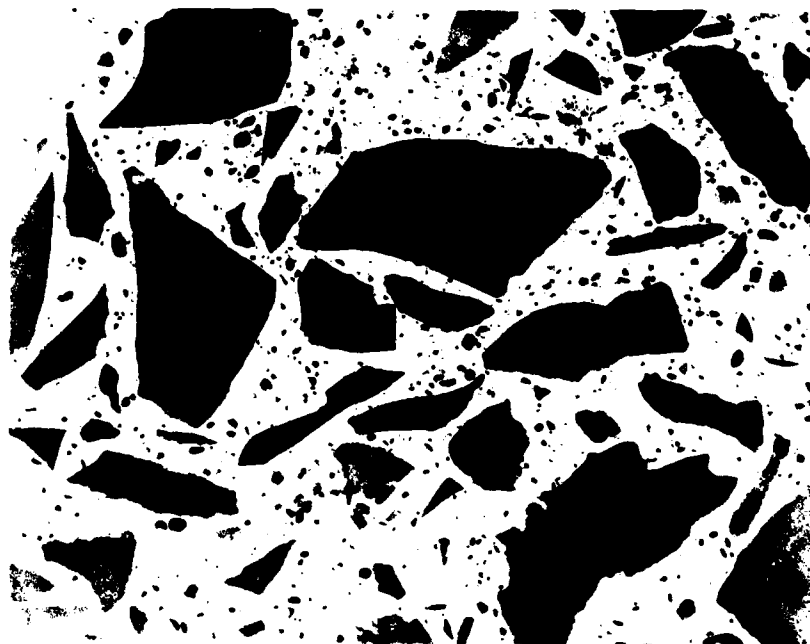
Photograph 2. Core MEM-5 CON-2 is typical of concrete in Type A section.
Nonair-entrained concrete with crushed carbonate coarse aggregate and
natural siliceous fine aggregate

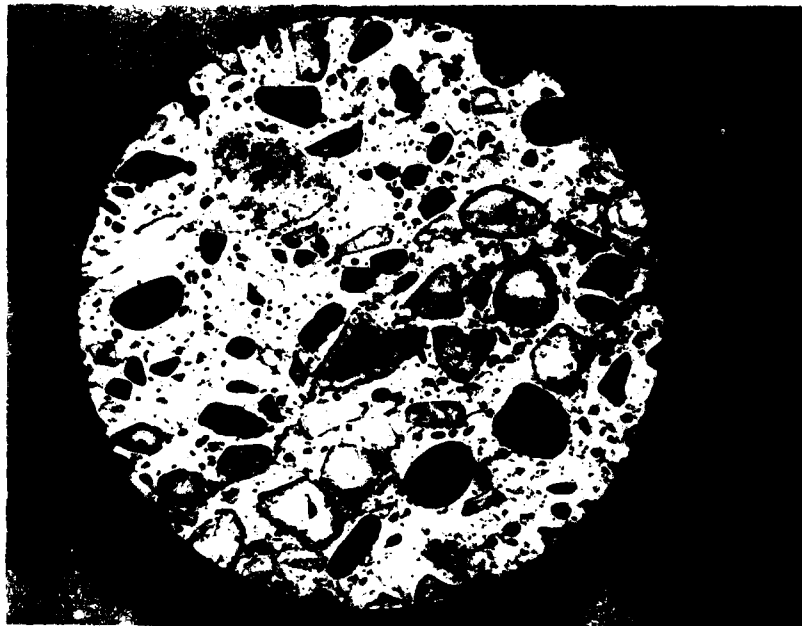
Photograph 3. Core MEM-5 CON-7 is one of two types of concrete in Type B section. Nonair-entrained concrete with natural siliceous coarse and fine aggregate

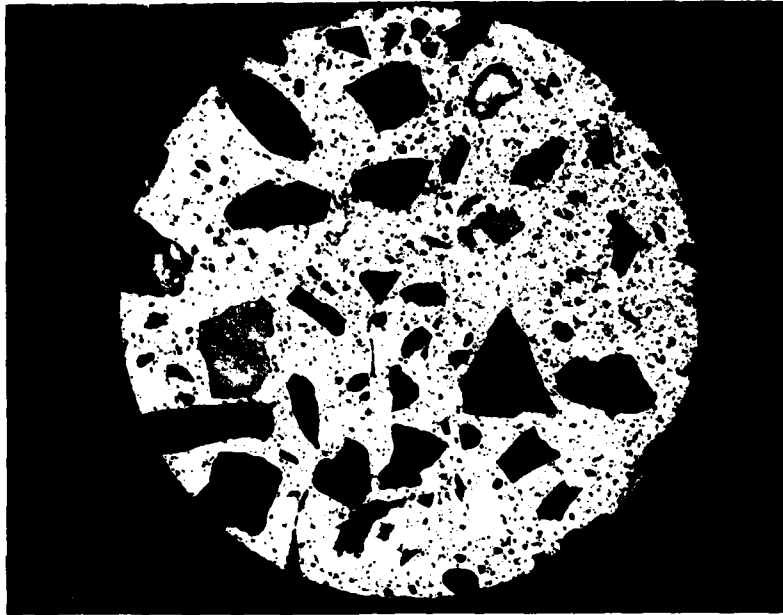
39. The maximum depth of deterioration was 3.0 ft in the old concrete core MEM-5 CON-8. This cracking of the concrete was not believed to be caused by alkali-silica reaction or frost action as was the case in other parts of the structure. Cores MEM-5 CON-4 and 7 of old concrete were showing signs of advanced weathering due to frost action and alkali-silica reaction which will result in eventual loss of surface concrete integrity.

Photograph 4. Core MEM-5 CON-8 is one of two types of concrete in Type B section. Nonair-entrained concrete with crushed limestone coarse aggregate with occasional quartz gravel particle and a natural siliceous fine aggregate

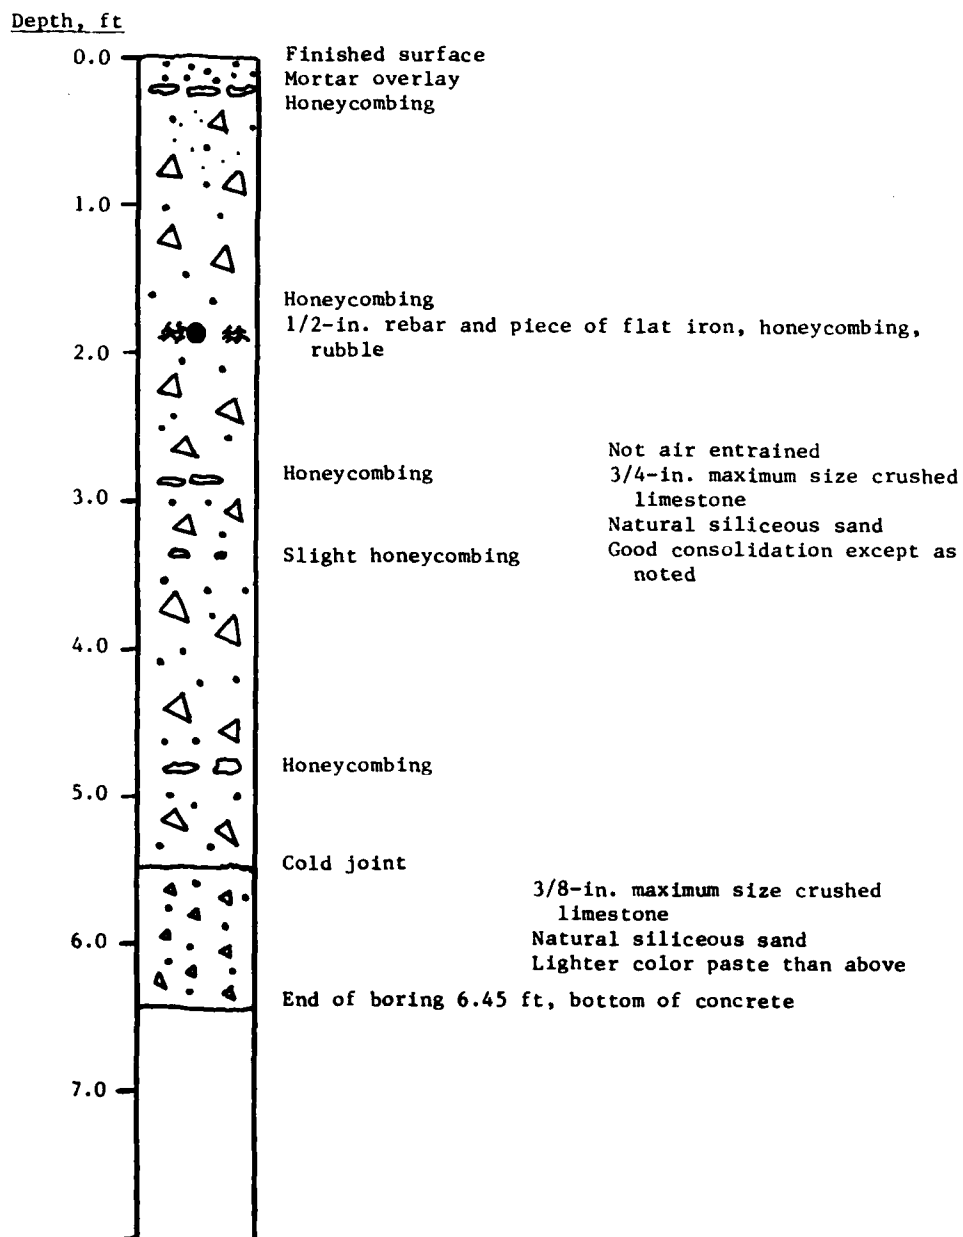
PLATE 3

MEM-5 CON-3 (New concrete, horizontal boring)
Caruthersville Floodwall, Caruthersville, Missouri,
6-in.-diameter core

Concrete is like MEM-5 CON-1

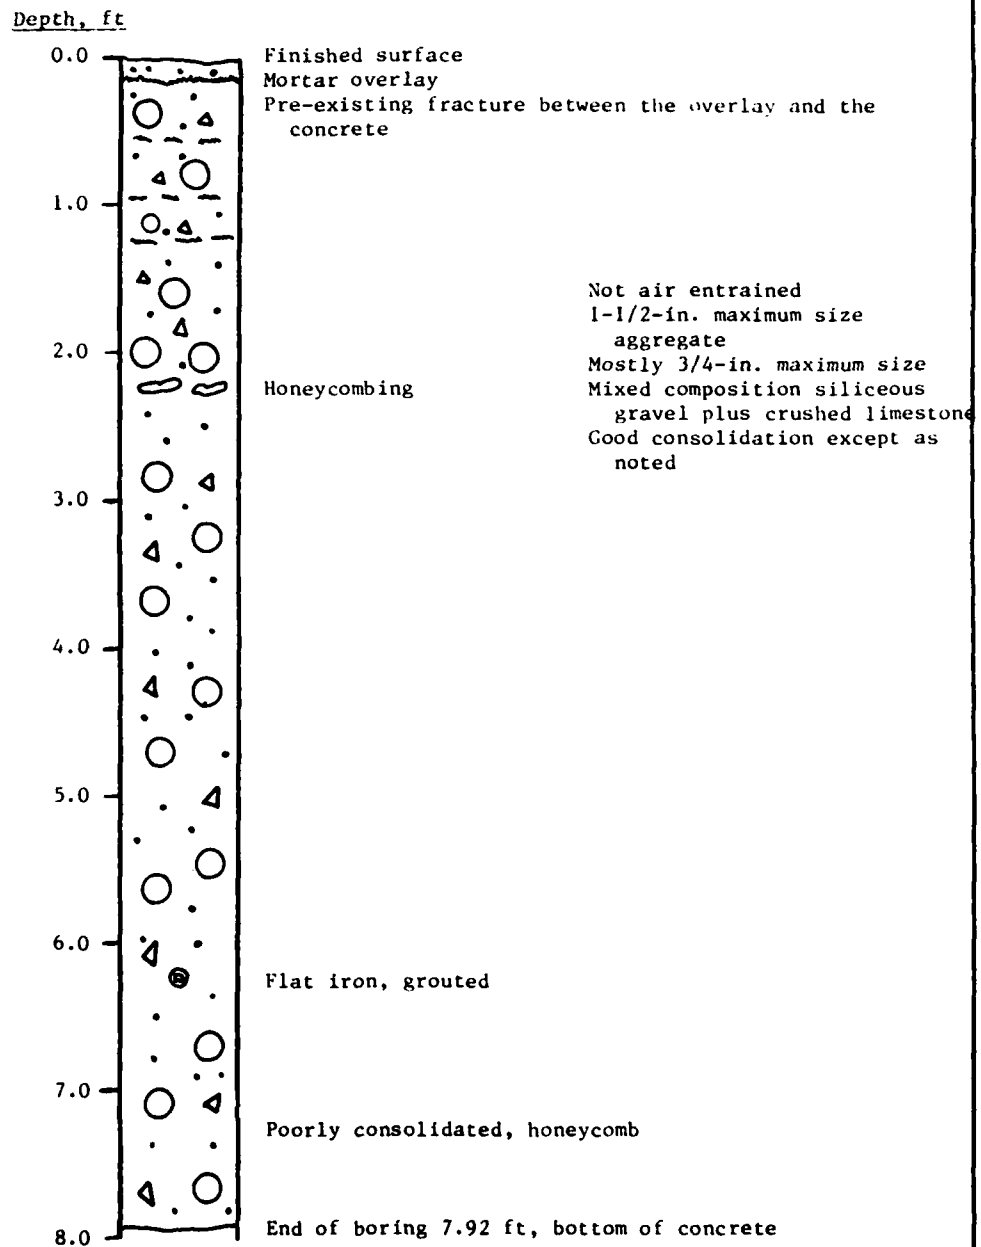
PLATE 5

MEM-5 CON-5 (old and new concrete, horizontal boring)
Caruthersville Floodwall, Caruthersville, Missouri
6-in.-diameter core

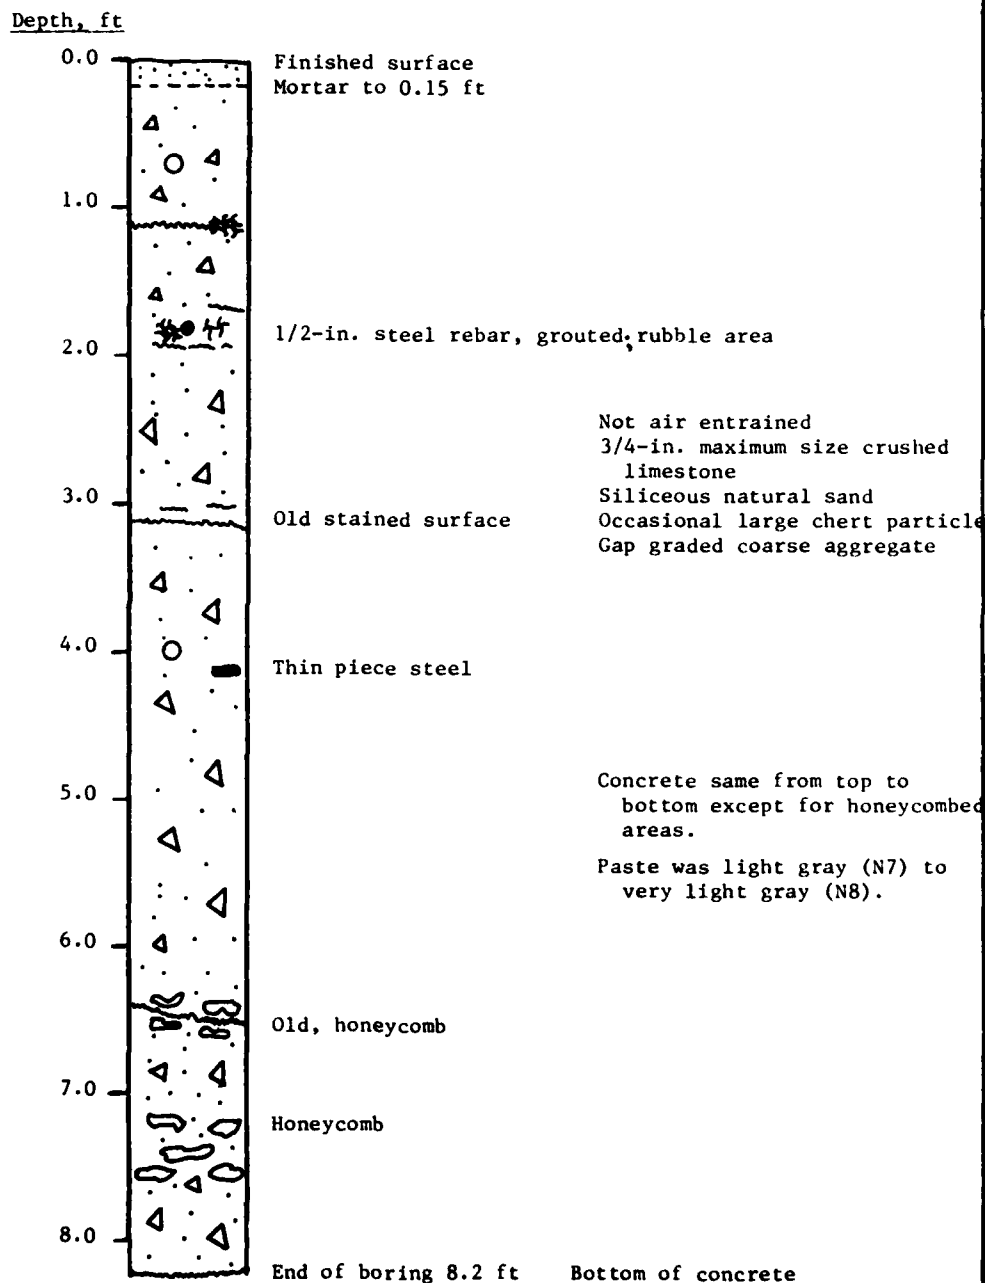
PLATE 9

MEM-5 CON-9 (New and old concrete, slant boring)
Caruthersville Floodwall, Caruthersville, Missouri
6-in.-diameter core

Concrete in good condition
No segregation
Good consolidation
